Manhole Inspection Summary

Manhole # S21K__026MH

Location Address: **1844 wilhelm st**

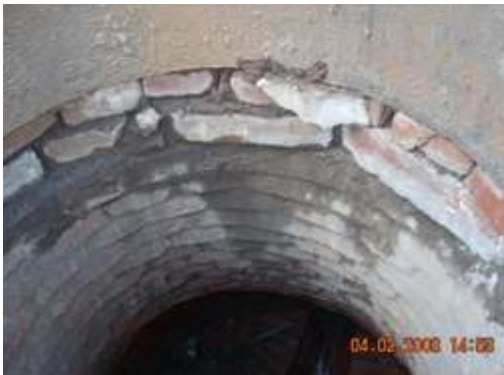
Defect 1

Chimney / Frame Adjustment ☒ Exists Material: **Brick and Concrete** ☐ Parged Height: **3** (in.)

Infiltration: ☐ None ☒ **Joint** ☐ Cracks ☐ Mortar ☐ Roots ☐ Wall

infiltration @ chimney joint

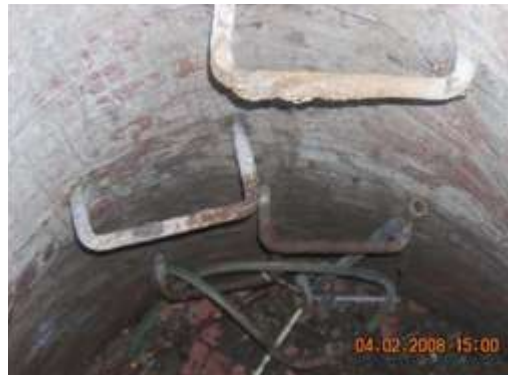
Defect 3

Steps Count: **4** Missing: **0** ☒ **Corroded**

corroded steps

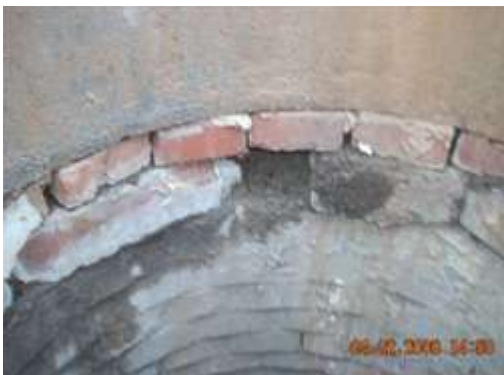
Defect 2

Condition: ☐ Sound ☐ Cracked ☐ Root Intrusion ☒ **Loose Brick** ☐ Deteriorated

loose chimney bricks

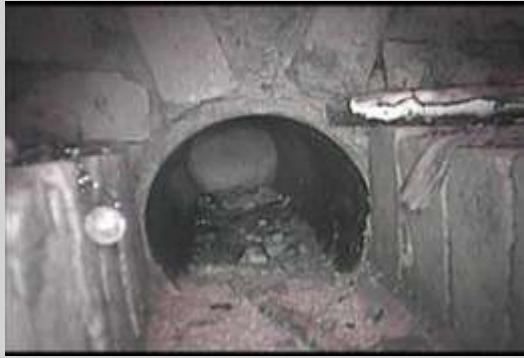
7 O'Clock Inflow

Deposits: ☐ None ☒ **Mud** ☐ Sludge ☐ Debris ☐ Grease

Silt Depth: **1** (in.) Deposits Extent: **Light**

Connects To: **Stub connection / abandoned**
